Private I/I Reduction - Chapel Drive Pump Station No. 2 Service Area Rehabilitation

Tad Powell, PE, Hazen

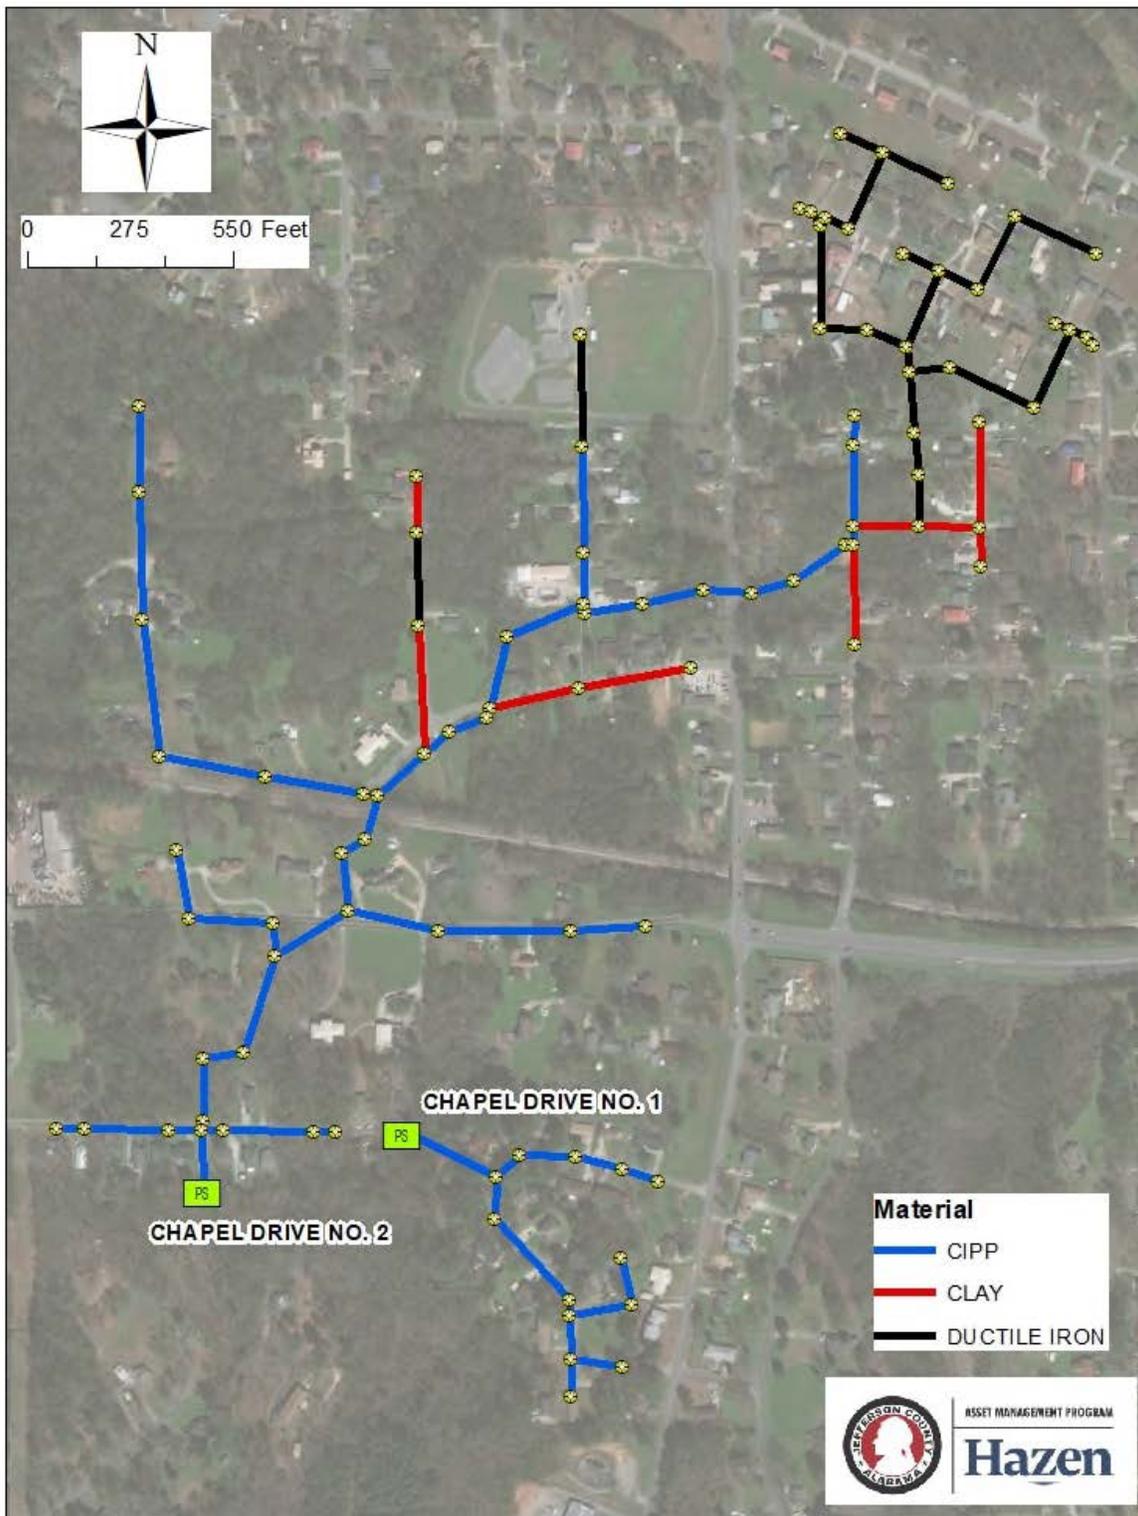
Figure 2. Chapel Drive No. 2 Collection System Pipe Type

Television inspection of the Chapel Drive No. 2 collection system identified 189 service lateral connections to the mainlines. Twenty-five (25) lateral connections were found on the newer DIP mainline that did not require attention. One hundred (100) laterals or 53% of these were inactive. This inactivity was mainly due to service laterals being installed during initial construction to vacant lots in anticipation of development or houses currently served by septic tanks. Most of the lateral launch inspections showed active leaks.

The approach for rehabilitation of the mainlines was straightforward. CIPP would be installed in all VCP pipes; the DIP pipes did not require rehabilitation at this time as it pertains to infiltration. The DIP is however cement lined and is susceptible to future corrosion. The remaining 11 manholes with adjoining CIPP (existing or scheduled) would also be scheduled for rehabilitation.

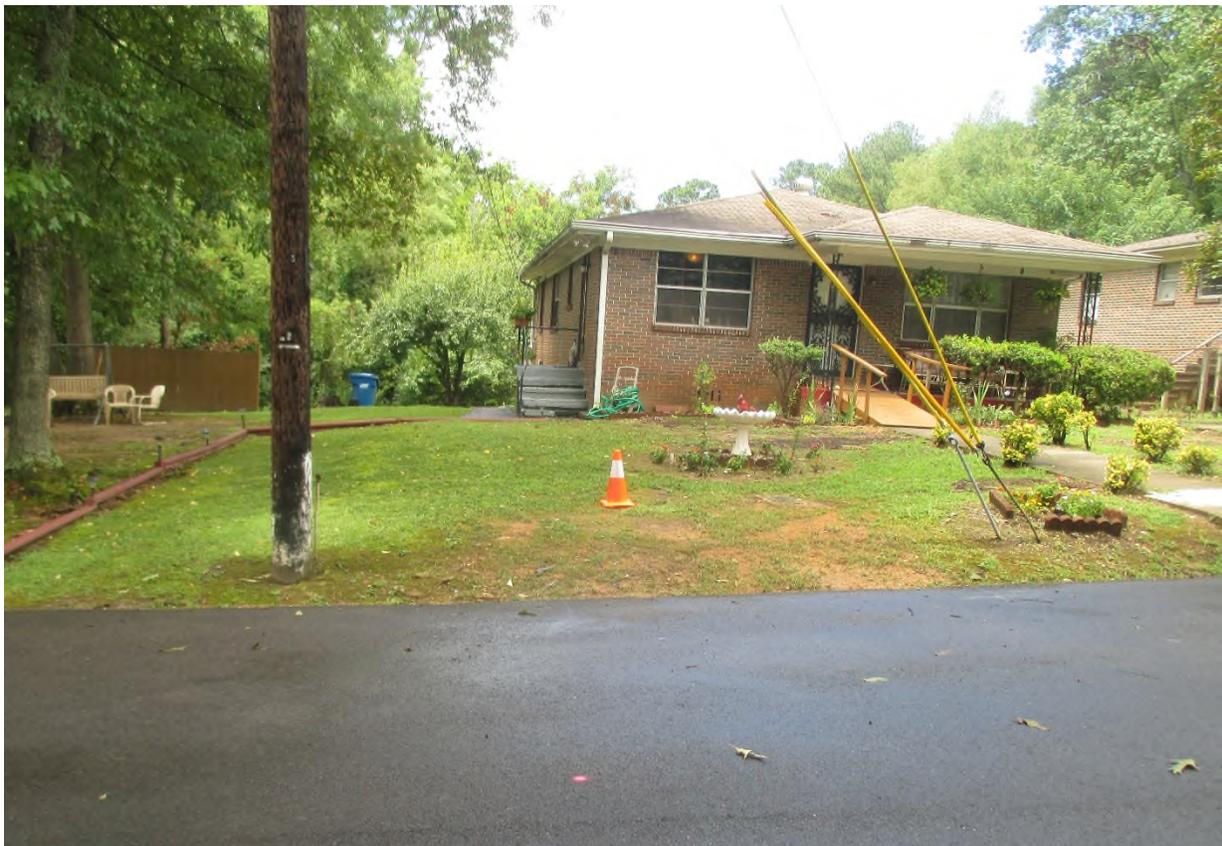
Figure 3. Lateral Launch Inspection Photo Marking the Clean Out Location

Lateral launch television inspections were performed using a self-leveling radial view camera with electronic locating technology launched from the mainline up the service connections. Cleaning of the lateral pipe was sometimes necessary to complete the inspection. All inspections were coded using PACP (Pipeline Assessment Certification Program) coding developed by NASSCO (National Association of Sewer Service Companies). Once the inspection reached the property line, an above ground location was noted and recorded. For this project, a clean out was to be installed on all active service lateral connections at the property line to allow for low pressure air testing after rehabilitation or replacement. Figure 3 is an inspection photo showing the location of the proposed clean out as shown by the traffic cone. Measurements were recorded to be able to reproduce this location at the time of construction.

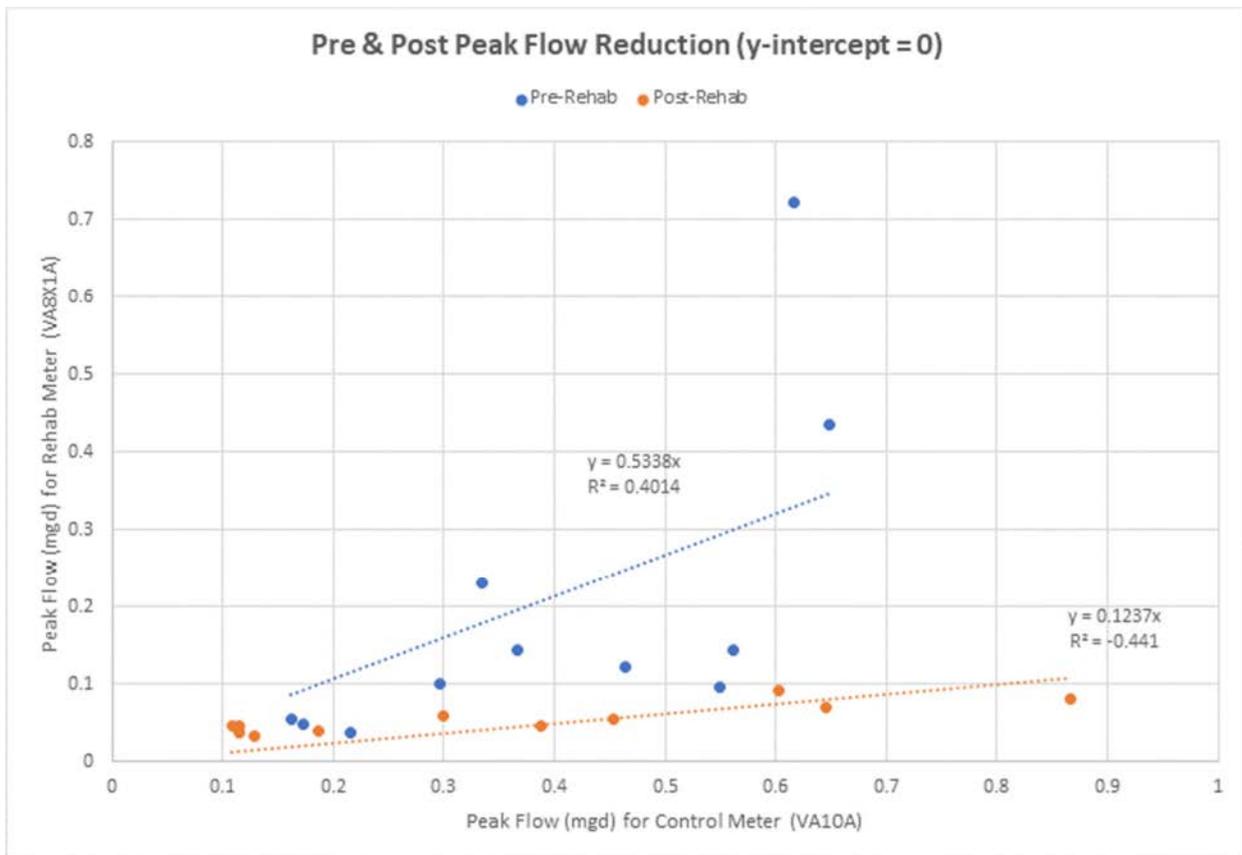
Figure 3. Peak Flow Reduction

The Chapel Drive Pump Station No. 2 Service Area Rehabilitation Project was completed in early Summer 2018. The initial post rehabilitation flow monitoring at the station is showing significant results, with a 90% reduction in volume and a 70% reduction in peak flow as shown in Figure 3.
