BLD Spot Repair provides a structural solution without lining the entire pipe. The CIPP Spot Repair addresses short lengths of damaged pipelines and conduits by the installation of a resin-impregnated flexible liner, thus preventing the need to line the entire pipe segment from manhole to manhole.

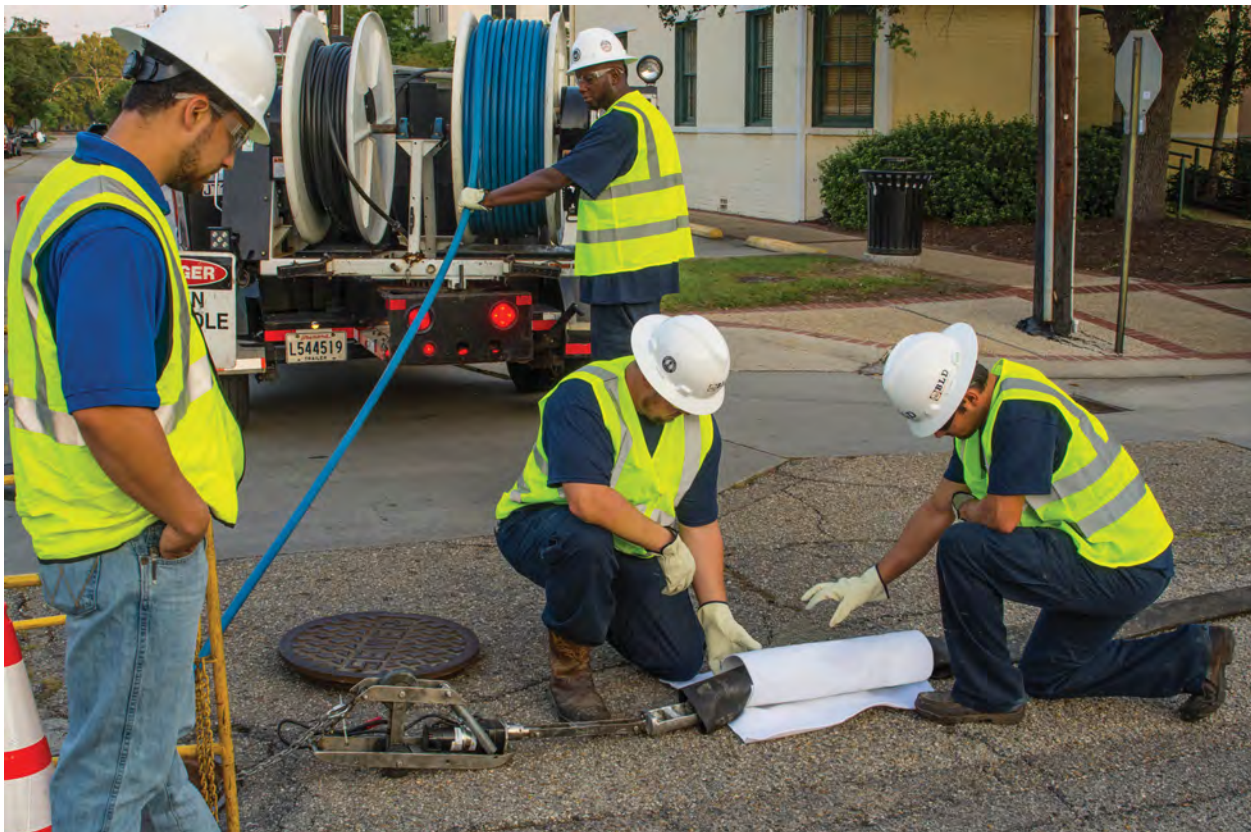
The CIPP Spot Repair is installed over the damaged pipe to form a hard, impermeable, corrosion resistant pipe-within-a-pipe. The result is a structurally sound, long lasting, and economical alternative to grouting, excavation, or manhole to manhole pipe rehabilitation.

A liner, similar to that used in full length main pipe rehabilitation, is used for all repairs. The liners consist of one or more layers of flexible needled felt that are fabricated to a size that will fit tightly to the internal diameter of the host pipe, thus resulting in a tight-fitting and seamless pipe-within-a-pipe.
