CIPP Spot / Point Repairs

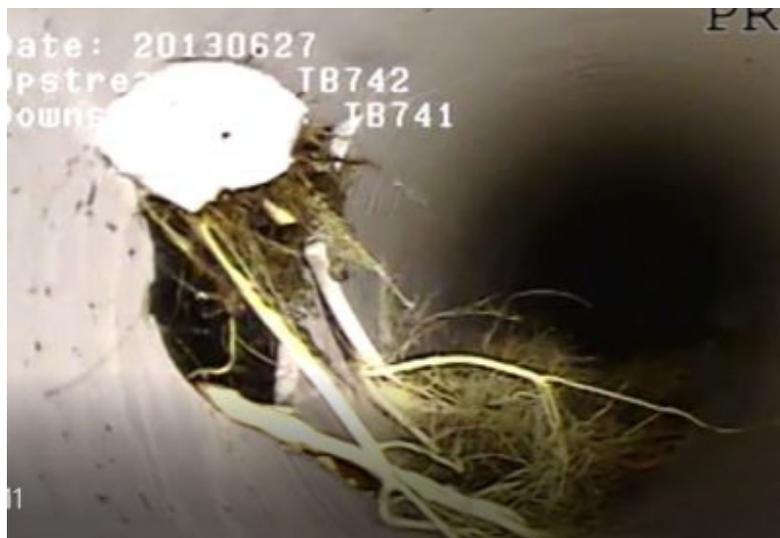
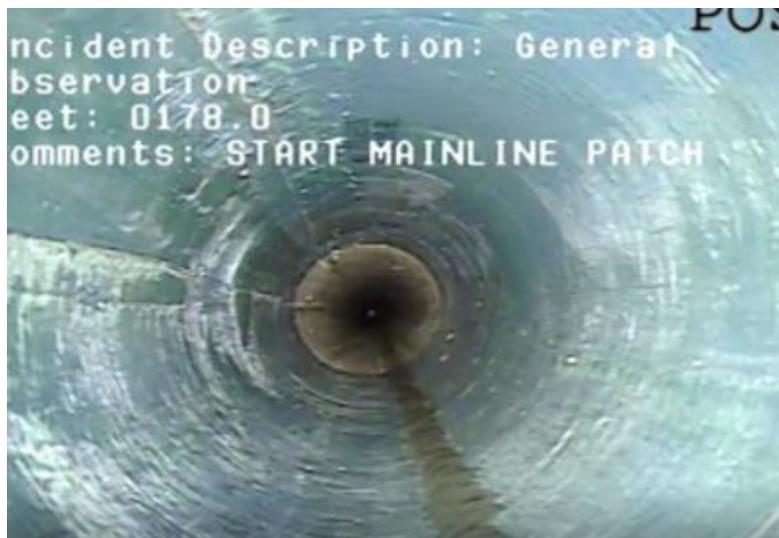
The damaged area(s) of the main line is inspected using a remote-controlled camera system. This inspection provides valuable information about the condition and profile of the damaged area(s) of the main line pipe. It is necessary to thoroughly clean the pipe prior to the rehabilitation process. We typically use high-pressure water to free areas of roots, mineral deposits, grease, sand and sludge. After cleaning, and before installation, another inspection ensures that the damaged area(s) is prepared for rehabilitation.
